Restoration Preparations

RESTORING BEAUTY, INSPIRING HOPE

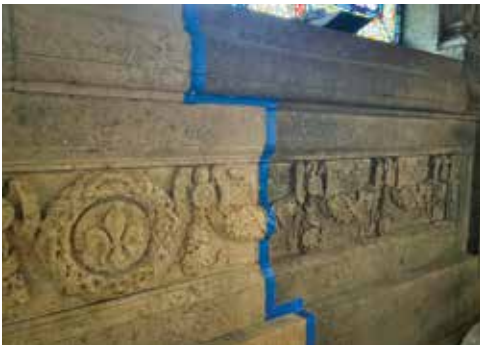
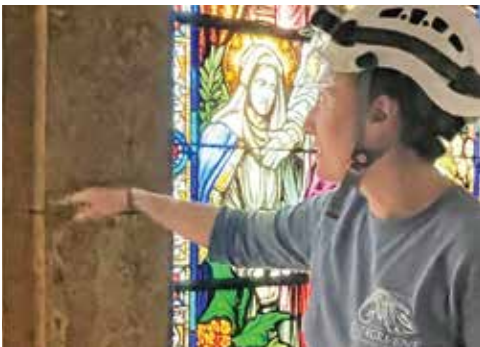
Cleaning tests were performed in select areas to determine the best restoration approach for interior stonework. Test results demonstrated that mild cleaning agents safely and effectively removed decades of surface soiling, revealing the natural color and pattern variations of the stone.

Explaining the cleaning process and the cleaning material being applied.

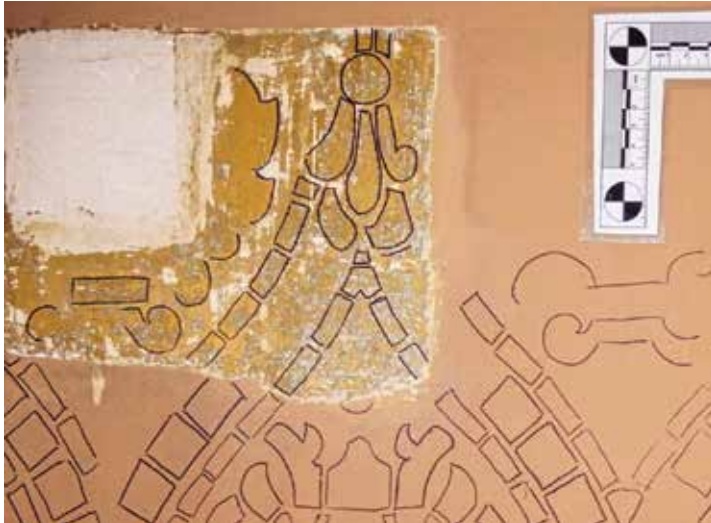
The historic artwork, described by Monsignor Reardon, was recently analyzed by EverGreene’s conservators. Traces of original artwork were revealed through test openings created in over-painted

areas and with bright or raking lighting. Where accessible, the historic color palette and visual evidence of stenciling has been documented. Current trials will help determine conservation feasibility and will also provide an opportunity to consider the impact of lighting and cleaning on overall appearance and aesthetics.

Historic stenciling revealed

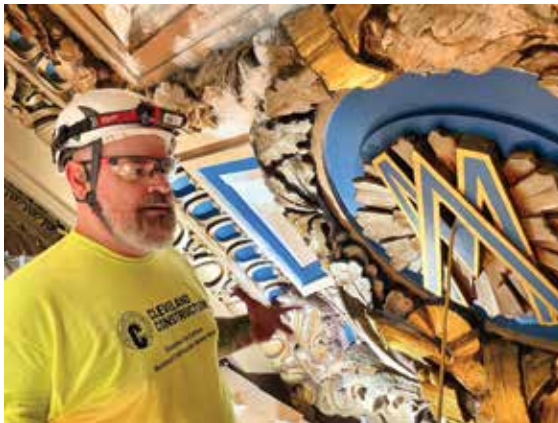
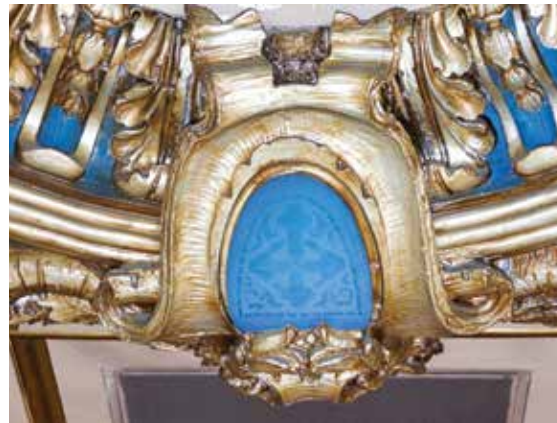
A painter working on AM ceiling medallion, *Auspice Maria*, which means “under the protection of Mary.”

There are 10 medallions around the perimeter of The Basilica ceiling.

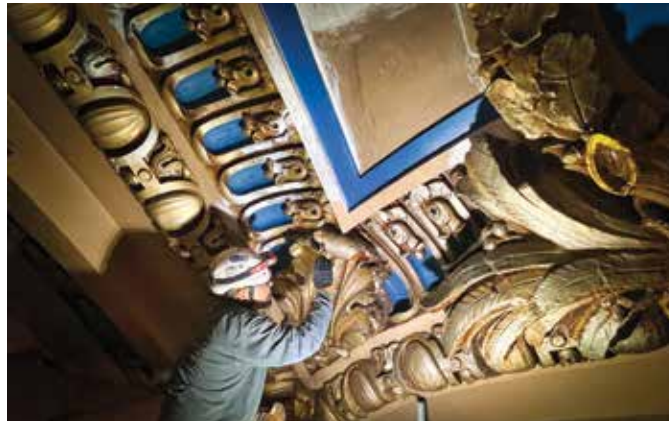
EverGreene’s conservators assessed damaged plaster, from both sides of the ceiling, to evaluate the extent of previous water damage. Prolonged water infiltration from roof leaks and unsound masonry joints have caused significant damage—including efflorescence (a deposit of salts on the surface of a porous material caused by water migration), cracking, and finish failures across The Basilica ceilings.

Plaster worker on scaffolding

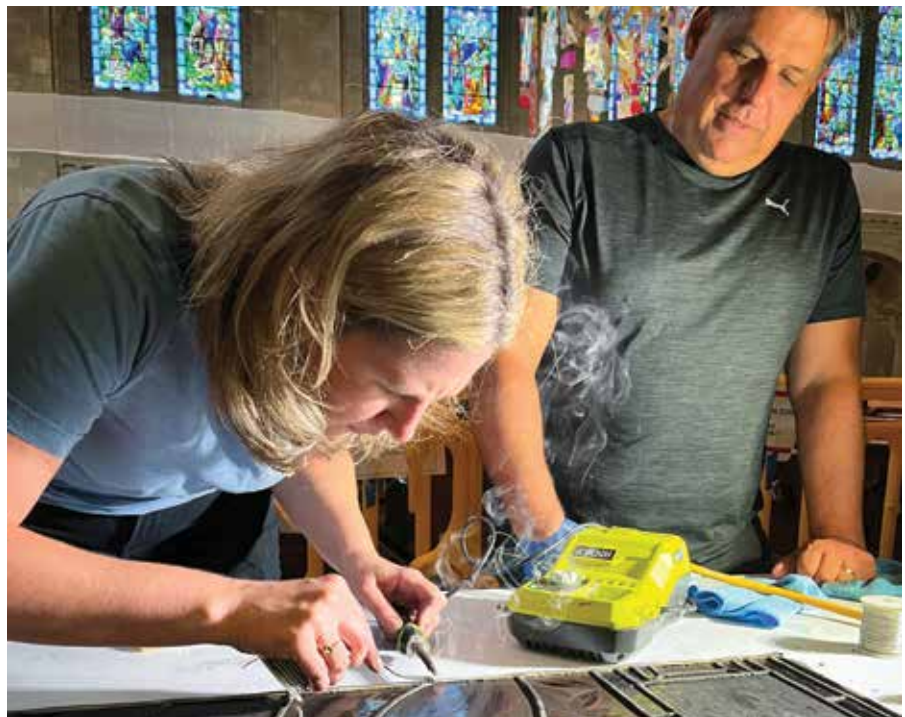
Liberty Stained Glass Conservation concluded, through visual observation, that stained glass is generally in stable condition, at least for the immediate future. Many of the windows have been previously restored in place with varying degrees of success. Regardless of previous restoration efforts, there is some untreated breakage and evidence of continued water infiltration. Another concern is the condition of the glass support system.

Properly installed and spaced support bars contribute to the integrity and long-term durability of the window. It is hard to assess the strength of lead or its remaining lifespan while a window is in situ (in place). The intent of the trial is to assess the condition of the lead strips, called “comes,” that hold the glass together, and feasibility of future repair.

Brianne Van Vorst, Principal and Conservator of Liberty Stained Glass Conservation, working on a window.

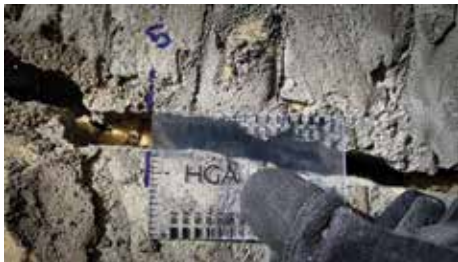
During the site investigation for the Building Envelope Study, HGA and their consultant, WJE, observed cracks throughout areas of the attic, primarily in and above the large arches at the base of the dome and the arch over the south balcony, but also at other, sometimes adjacent walls. Some of these cracks have been previously repaired, but the cracking extends beyond the repairs.

HGA structural engineers are currently investigating historic masonry and conditions that may be contributing to the observed cracking. The goal is to verify whether the cracks remain active and to determine if repairs or strengthening is necessary. Appropriate repairs will be designed as needed to effectively address the root causes of observed distress.

Monitoring cracks at masonry

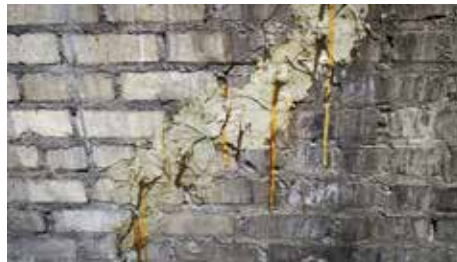
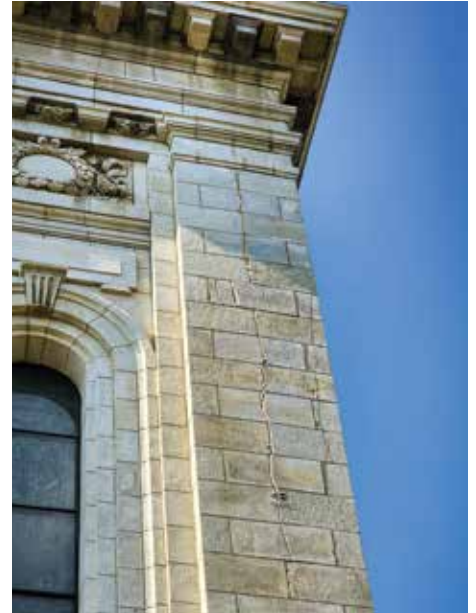
Exterior stone cracks

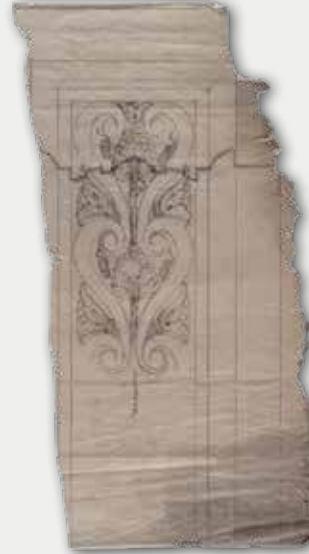
Slifer and Abrahamson. 1920–1927. “Grapevine and Grape Cluster Pattern for Plaster Ornamentation, Basilica of Saint Mary, Minneapolis, Minnesota.” (Basilica of Saint Mary Archives)
